INDIAN BROOK RESERVOIR  
WESTCHESTER COUNTY  
NEW YORK  
INVENTORY NO 44

PHASE I INSPECTION REPORT  
NATIONAL DAM SAFETY PROGRAM.

Name of Dam Indian Brook Reservoir NY44

State Located New York  
County Located Westchester  
Stream Indian Brook River  
Date of Inspection July 26, 1978

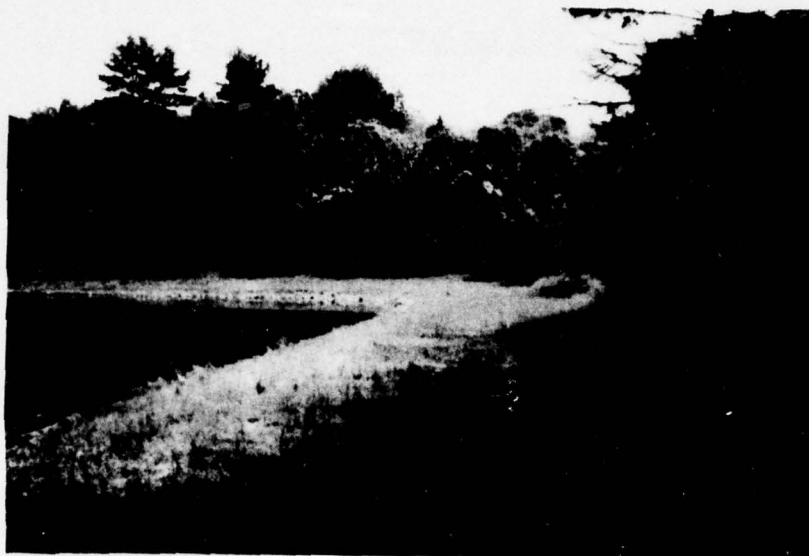
1. View of riprap towards south abutment.

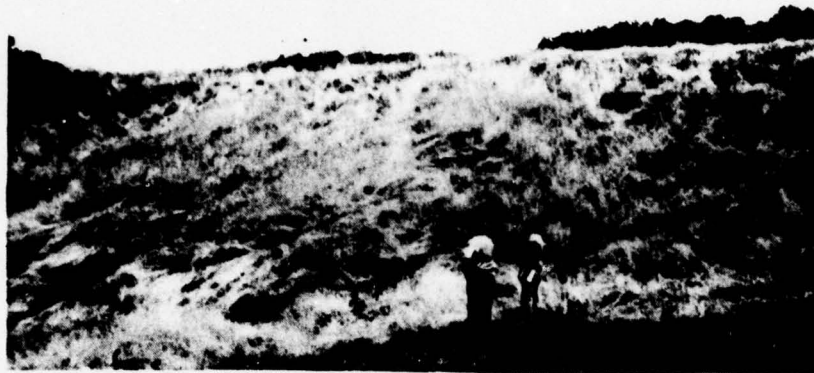
5. View looking north across downstream abutment. Note high grasses. Area being viewed reportedly seeps with high reservoir levels.

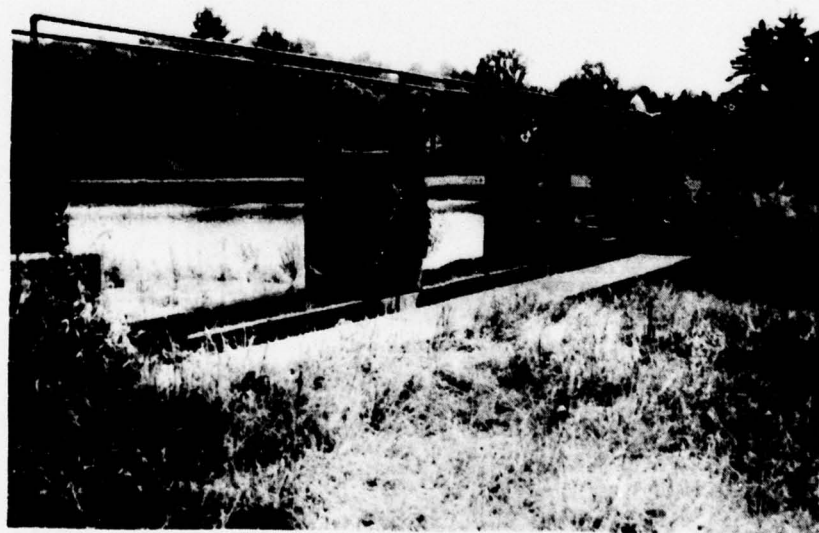
6. View across spillway at top of dam.

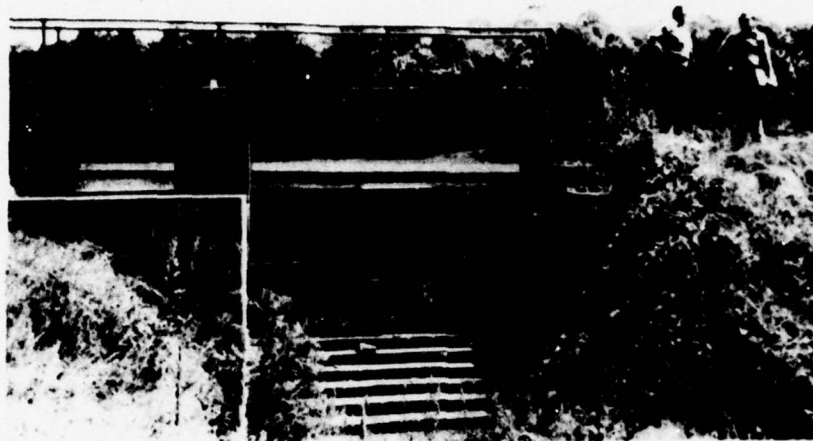
7. Another view looking up spillway.

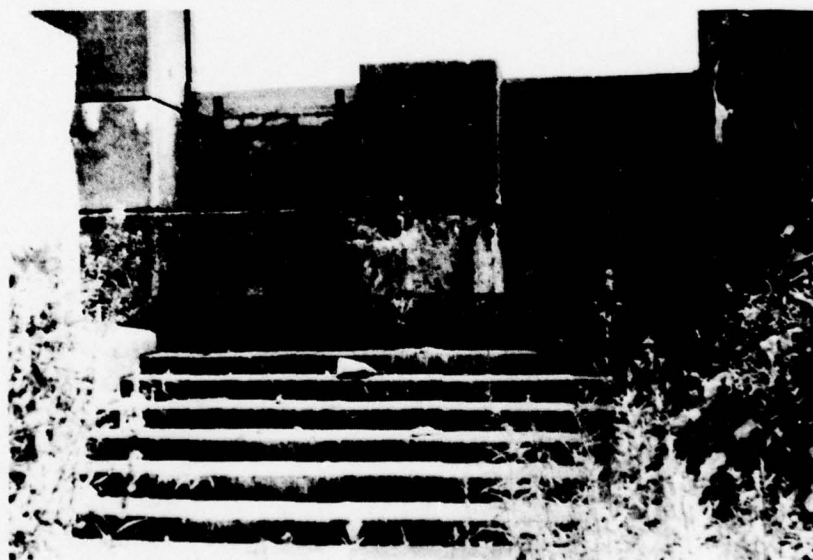
8. Block in center of spillway with damaged spillway sill.

VISUAL EXAMINATION OF	OBSERVATIONS	REMARKS OR RECOMMENDATIONS
CONCRETE WEIR	Generally the condition of the concrete is good. A masonry element in the center of the weir has become loose. (See Photograph in this report.)	
APPROACH CHANNEL	None.	
DISCHARGE CHANNEL	Spillway chute discharges into a spillway settling basin (not area previously discussed) and discharges over top of another sharp, crested weir.	
BRIDGE AND PIERS	None.

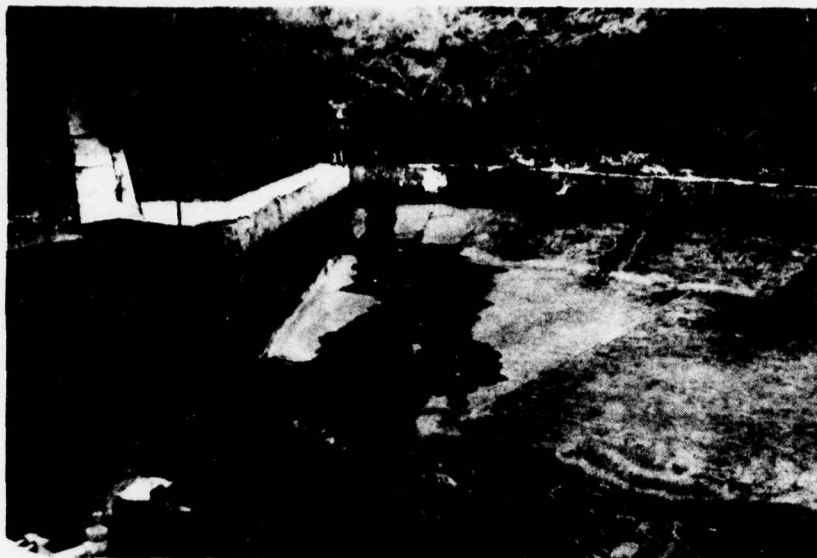
13. Seepage through wall in filtration basin.

A primary aeration basin and other water supply service structures are located immediately below the embankments downstream toe. What apparently is through-the-embankment seepage from or near abutment locations was outletting at two visible locations through the basin wall which extends along the toe of the slope. A trench in the aeration basin, serving as the location for a drawdown pipe, was experiencing a boil which presumably originates as reservoir under-dam seepage. Reportedly, the seepage condition originated approximately three years ago. The concrete slab floor of the aeration basin is cracked at various locations.

The dam embankment appears to be in good condition structurally, except for the noted seepage. Because of progressive-worsening of this type of boil typically associated with a condition of underdam seepage, and to a lesser extent for abutment leakage, provisions to significantly reduce the on-going seepage condition should be considered a priority requirement. The source and path of seepage require further investigation. On the basis of present information it is anticipated that a repair procedure such as clay mineral, chemical or cement pressure-grouting can be utilized to correct the condition.

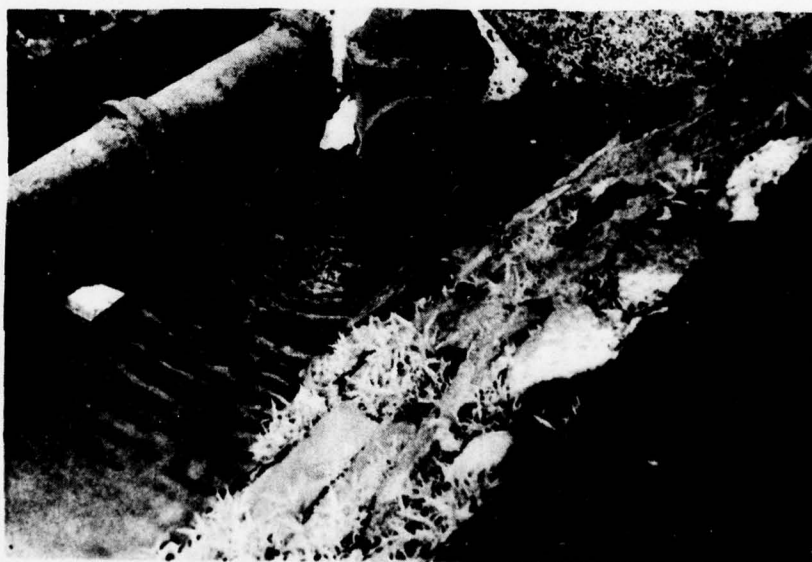
14. Closeup of boil in filtration basin area.

The boil is located in a trench in the aeration basin which presumably originates as reservoir underdam seepage. The boil was first noticed 3 years ago. The concrete slab floor of the aeration basin is cracked at various locations and some seepage is present. There is evidence of some on-going seepage through the embankment and at the downstream toe.

It is vitally important that the Village locate plans for the dam. Further investigations and remedial action will require some construction details on the dam. The boil in the basin significantly effects the dam's safety. Provisions to substantially reduce the on-going seepage conditions should be a priority requirement. The source and path of seepage require further investigations.
